2005-28

Final Report

Occurrence of Bumps in Overlays

9. Performing Organization Name and Address Department of Mechanical and Civil Engineering Minnesota State University, Mankato 205 E. Trafton Science Center Mankato, MN 56001		8. Performing Organization Report No.

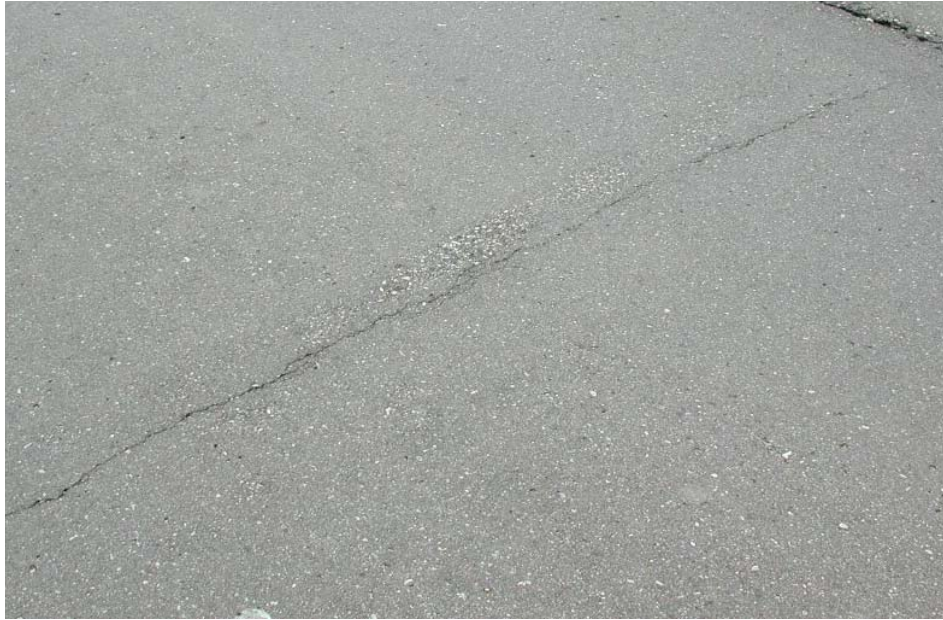
Figure 4.1. Transverse crack with overlay-related bump – Pipestone County.

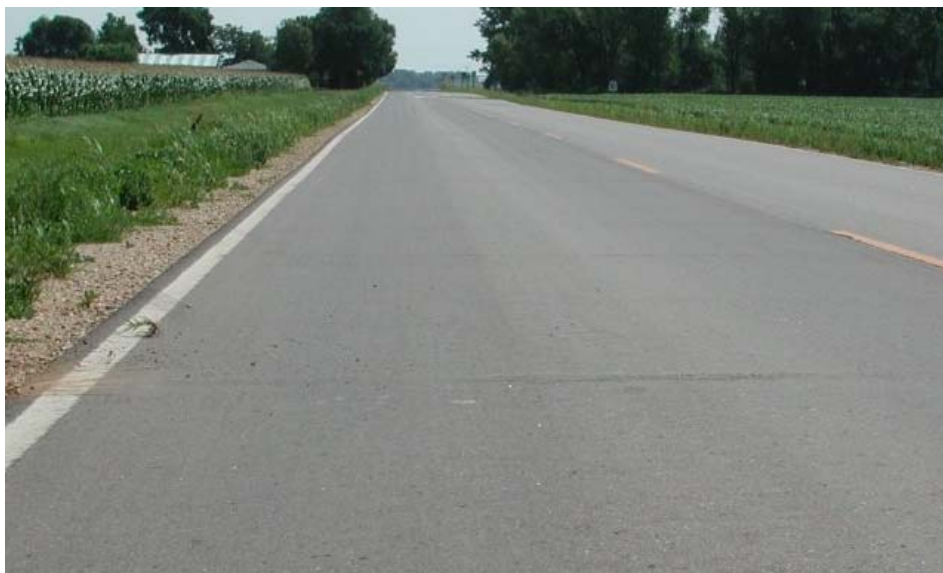
Figure 4.2. Several consecutive overlay-related bumps – Pipestone County.

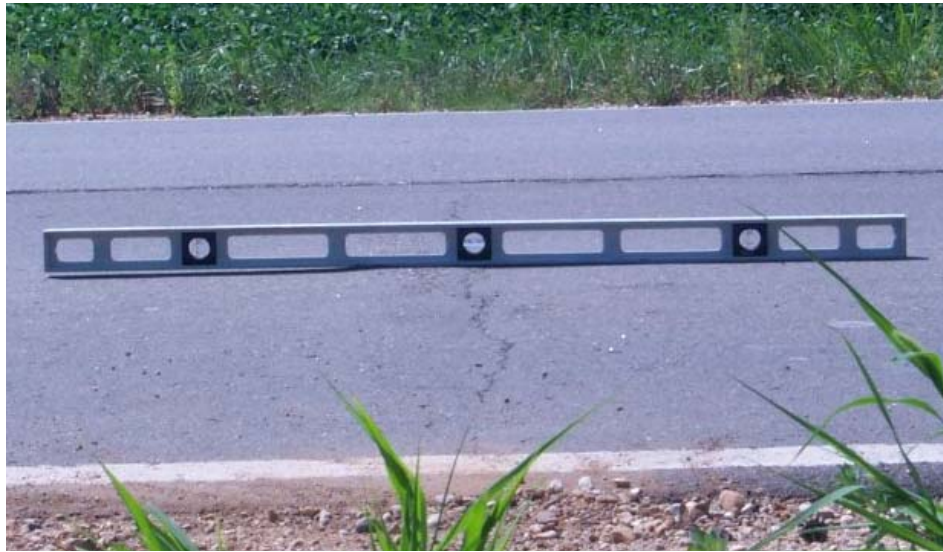
Figure 4.3. Straightedge showing effect of bump in pavement profile.

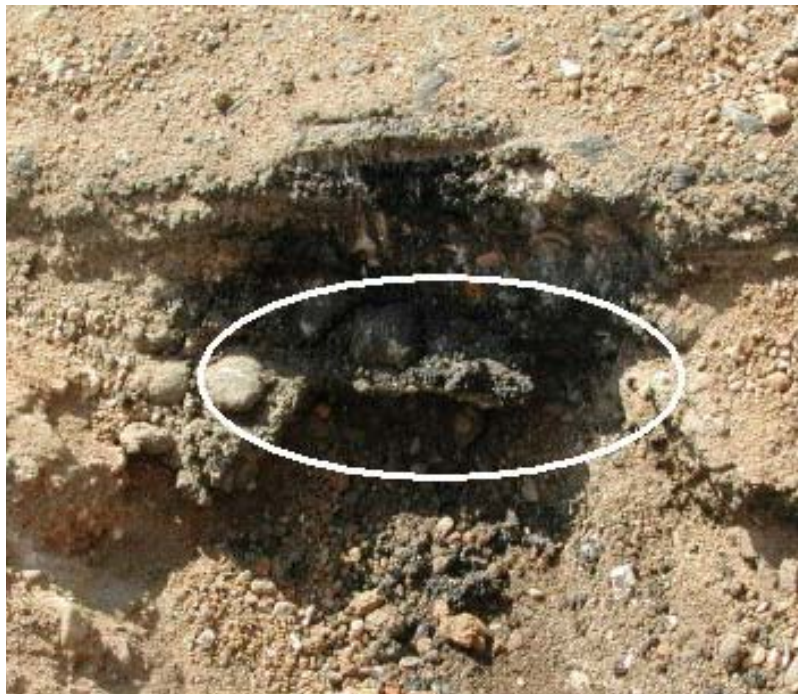
Figure 4.4. Cutaway section at pavement edge showing crack sealant at interface – Pipestone County.

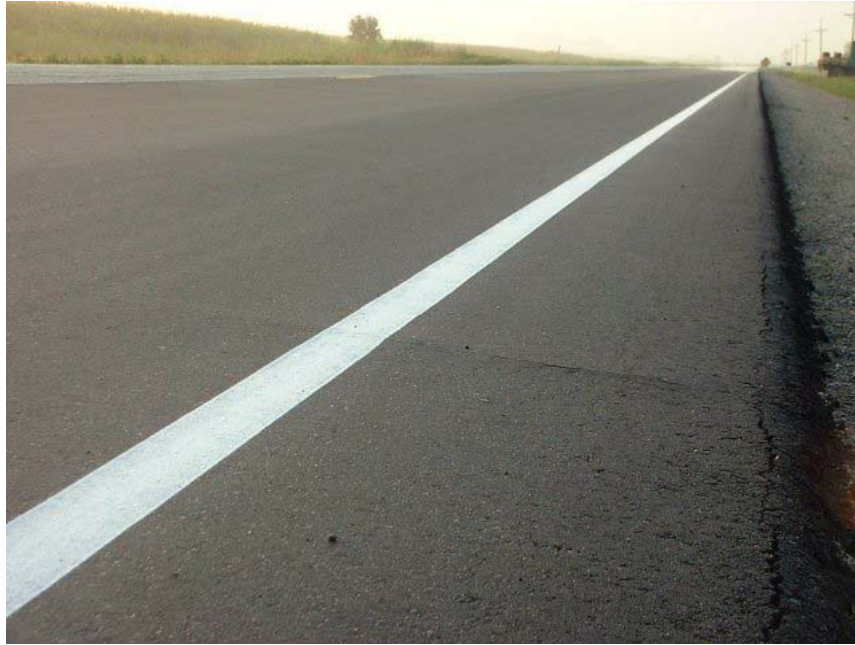
Several small bumps were observed near the first site (at MP 34), and fewer but larger bumps were found near the second site. The largest bumps found on any of the four instrumentation projects were found at the second site at TH 22 (near MP 19). Figure 6.6 shows a typical bump near MP 34, and Figure 6.7 shows one of the few large bumps observed near MP 19.

Figure 6.6. One of numerous small bumps found near milepost 34 on TH 22 near Mapleton, Minn.

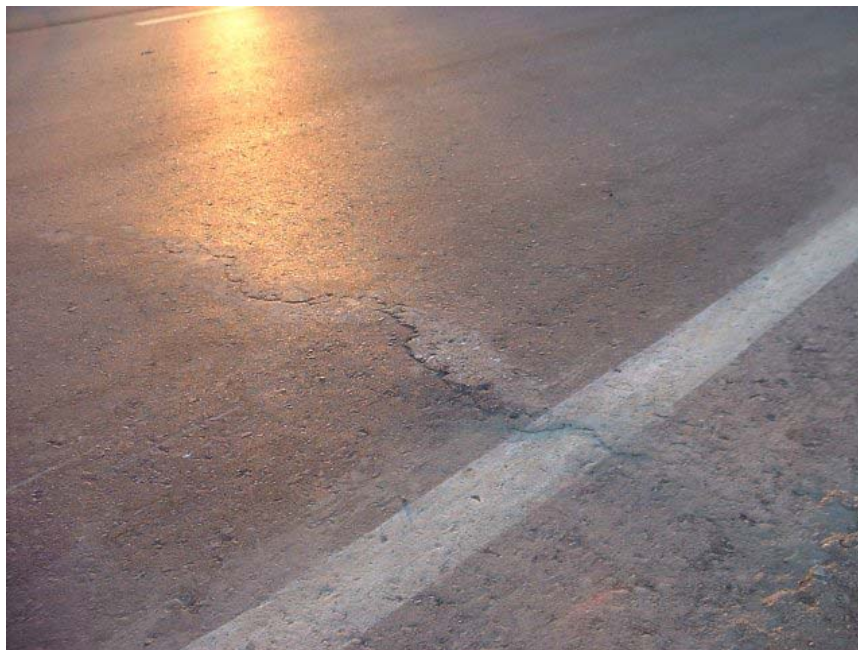
Figure 6.7. A Large bump near milepost 19 on TH 22 near Wells, Minn.

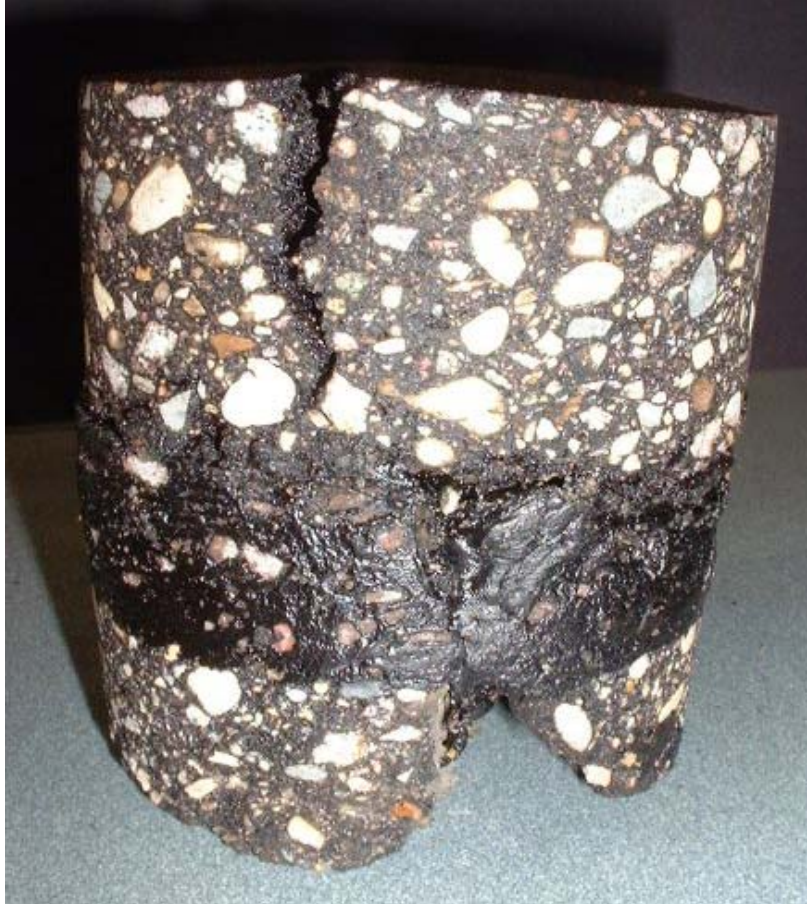
A core was taken at the location of a bump near MP 34 the morning after the first lift was paved. This core is shown in Figure 6.8. The crack found at the bump is larger than it was in the field. This core was taken from a bump location similar to that shown in Figure 6.6. The location of the crack in the core can be seen about 0.5 inch from the original crack in the existing surface.

Figure 6.8. Core removed from pavement near milepost 34 on TH 22.

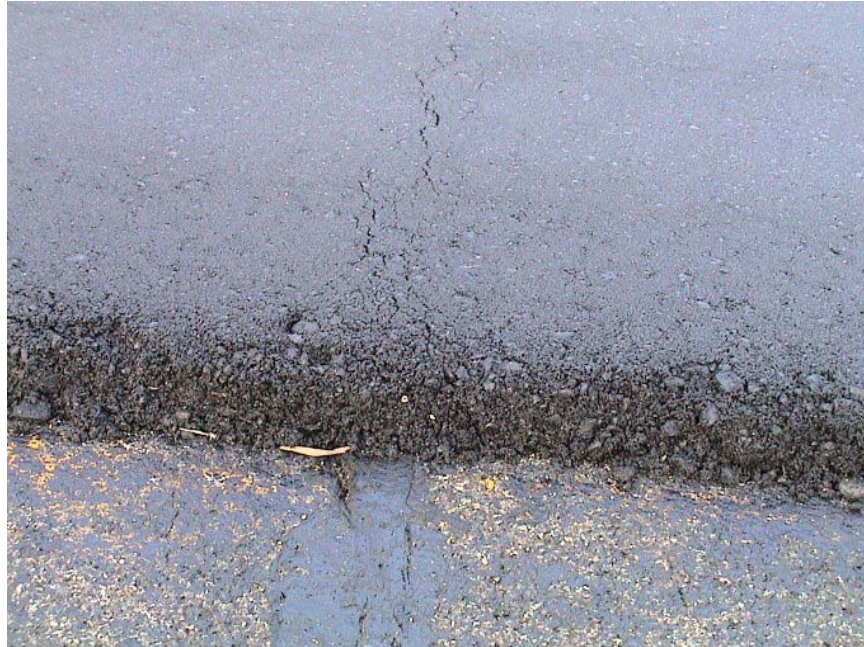
Figure 6.10. Bump at sealed crack on CSAH 9 in Lyon County.

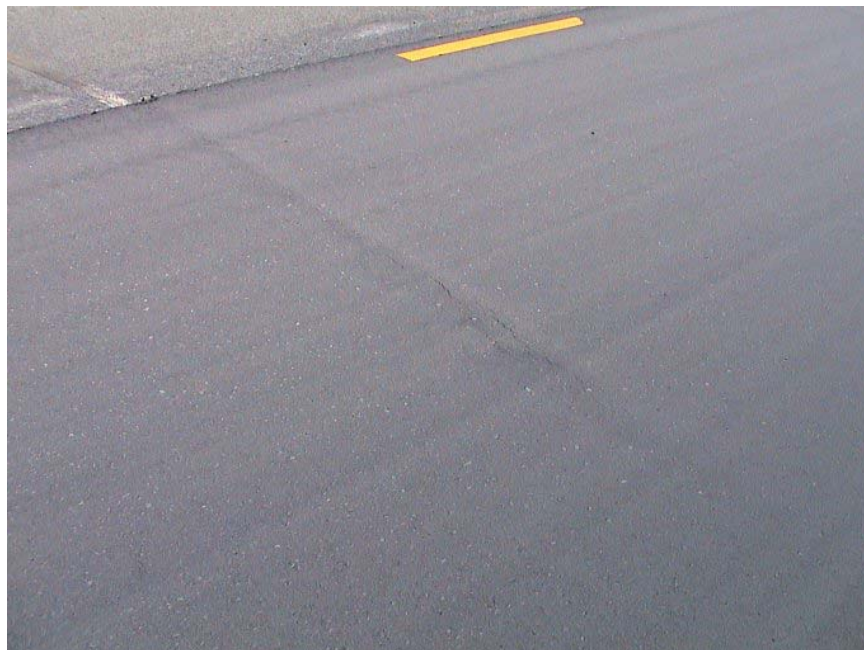
Figure 6.11. Bump at sealed crack on CSAH 9 in Lyon County.

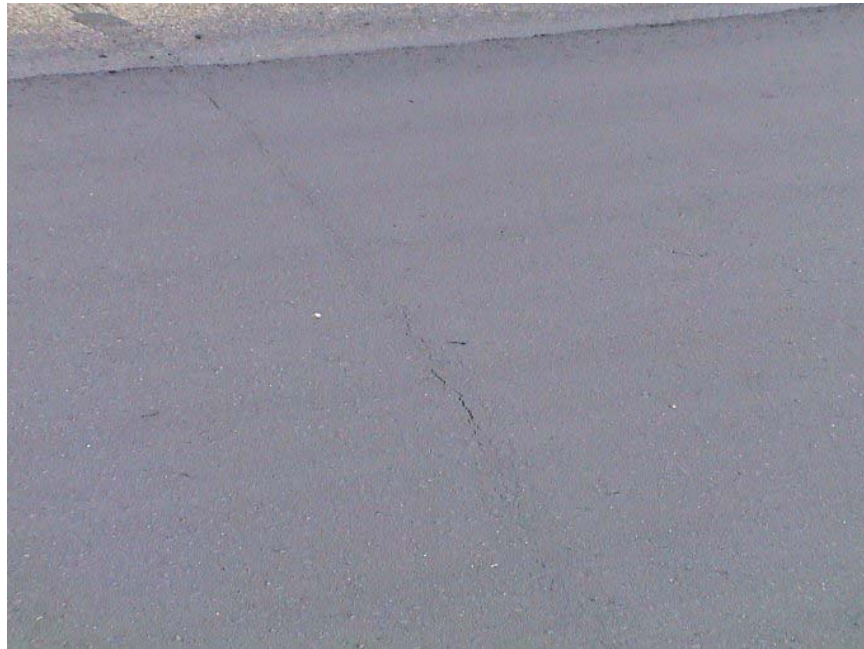
Figure 6.12. Bump at Sealed Crack at Lyon County CSAH 9.

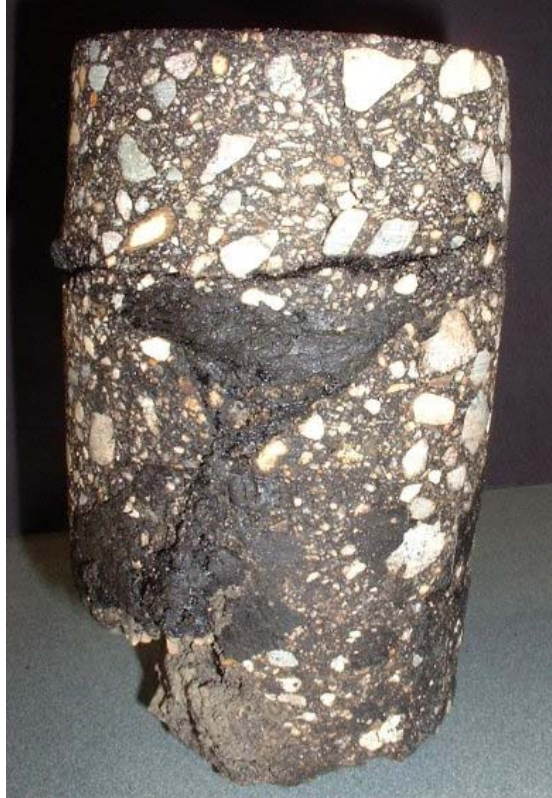
Figure 6.13. Core extracted from station 17+00 at the overlay project in Lyon County.

The core in Figure 6.13 shows the original crack just to the left of the center of the core, and a large mass of sealant just below the interface between the existing and new asphalt. In Figure 6.14, the sealant seems to be lower than the interface between the two layers, with a larger amount of new asphalt below the average level of the interface.

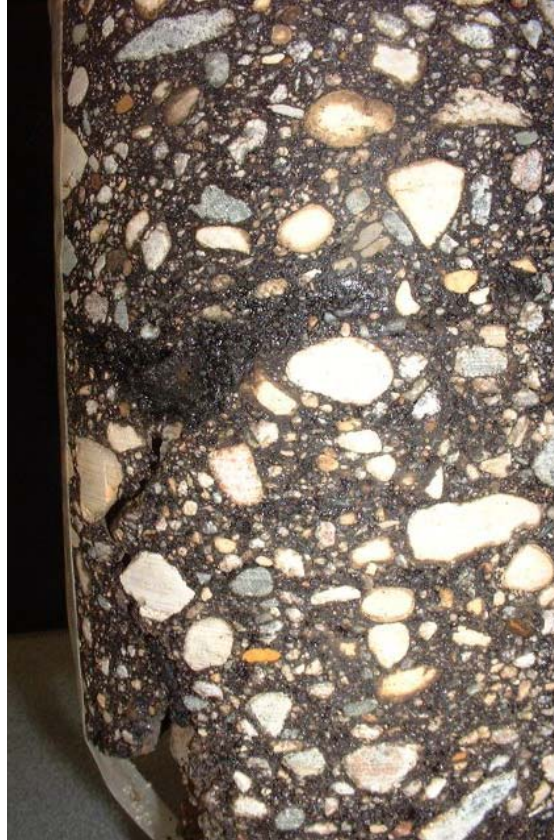
Figure 6.14. Core extracted from station 20+00 at the overlay project in Lyon County.

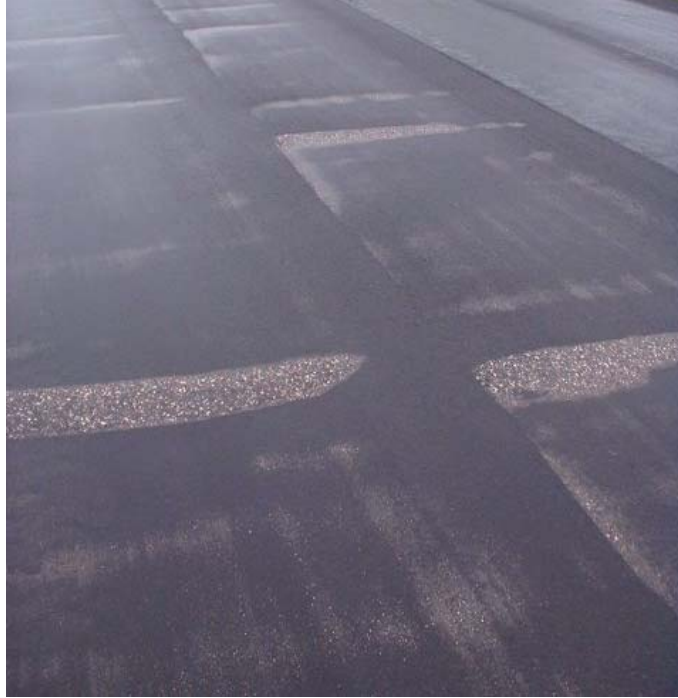
Dr. Wilde visited the site again on Tuesday, August 24, 2004, to obtain photographs and make observations before the second lift was placed. Bumps were observed, as expected, in the 200-foot section extending into Cottonwood County. The contractor had noticed the bumps as well, and ground them down to minimize the effect on smoothness. Some of the bumps observed that had been ground are shown in Figure 6.15. Very few, and very minor bumps were found in the Jackson County portion of the project. As noted, Jackson County had not sealed cracks on the project, while Cottonwood County had sealed them previously during the same season.

Figure 6.15. Bumps in 200-foot section in Cottonwood County.

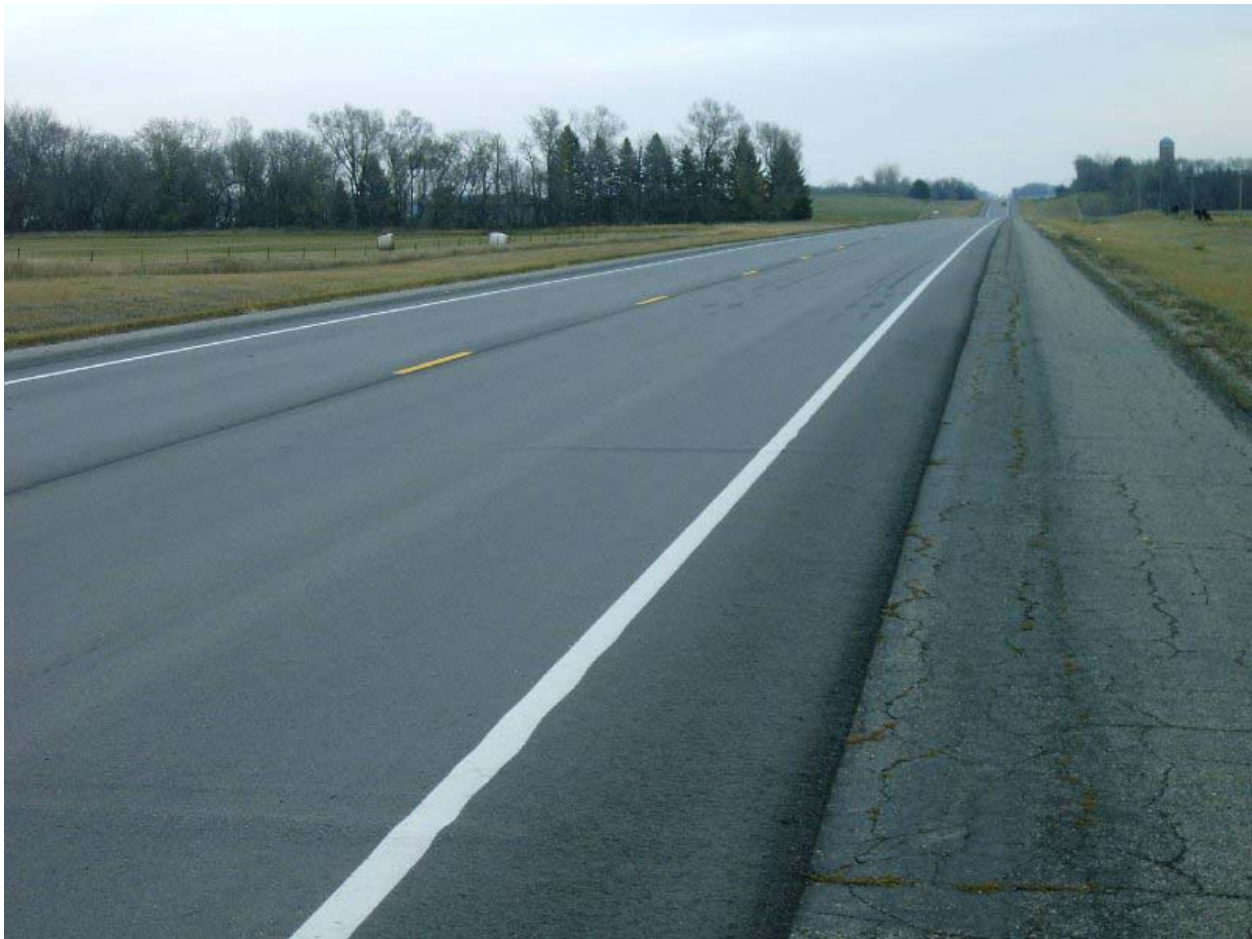
Figure 6.17. Bumps in overlay on US 212 in District 8.

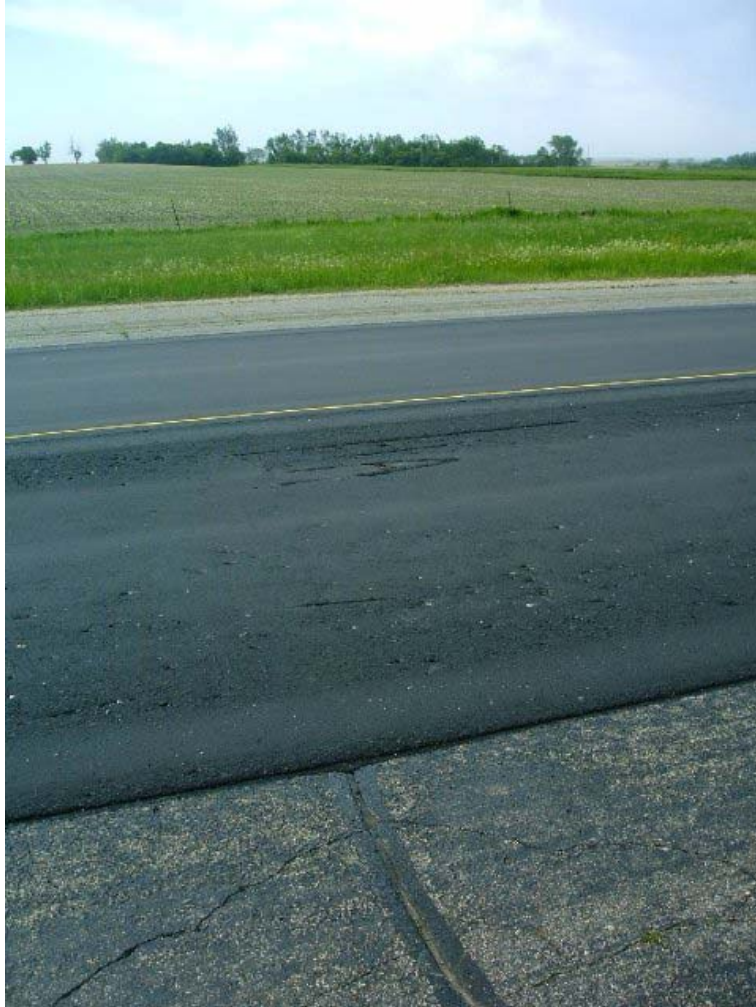
Figure 6.18. Paver-laid thin-lift overlay on US 212.
