2005-28

Final Report

Occurrence of Bumps in Overlays

9. Performing Organization Name and Address Department of Mechanical and Civil Engineering Minnesota State University, Mankato 205 E. Trafton Science Center Mankato, MN 56001		8. Performing Organization Report No.

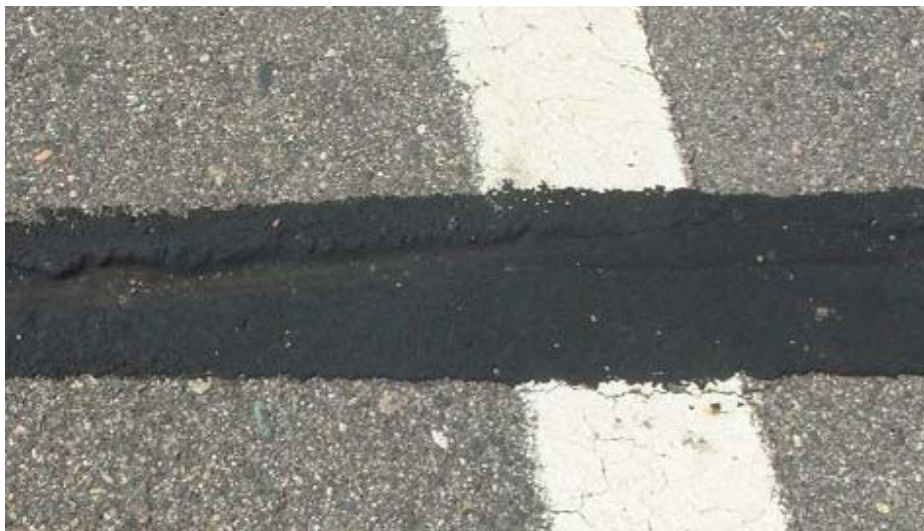
Figure 4.5. Routed and sealed crack, no overlay, Todd County.

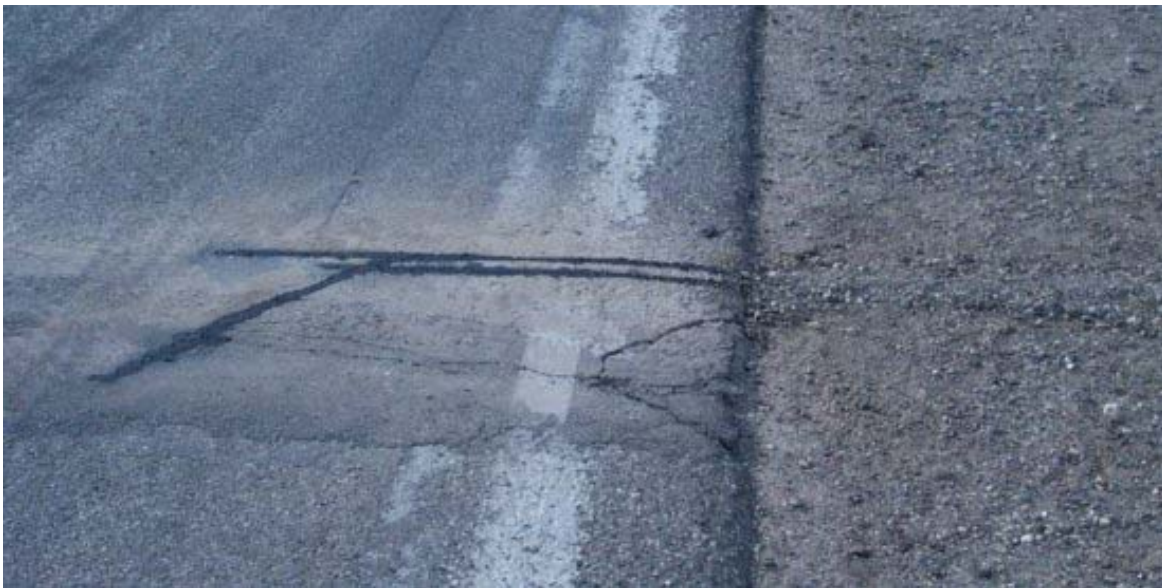
Figure 6.1. Close up photograph of thermocouple installation.

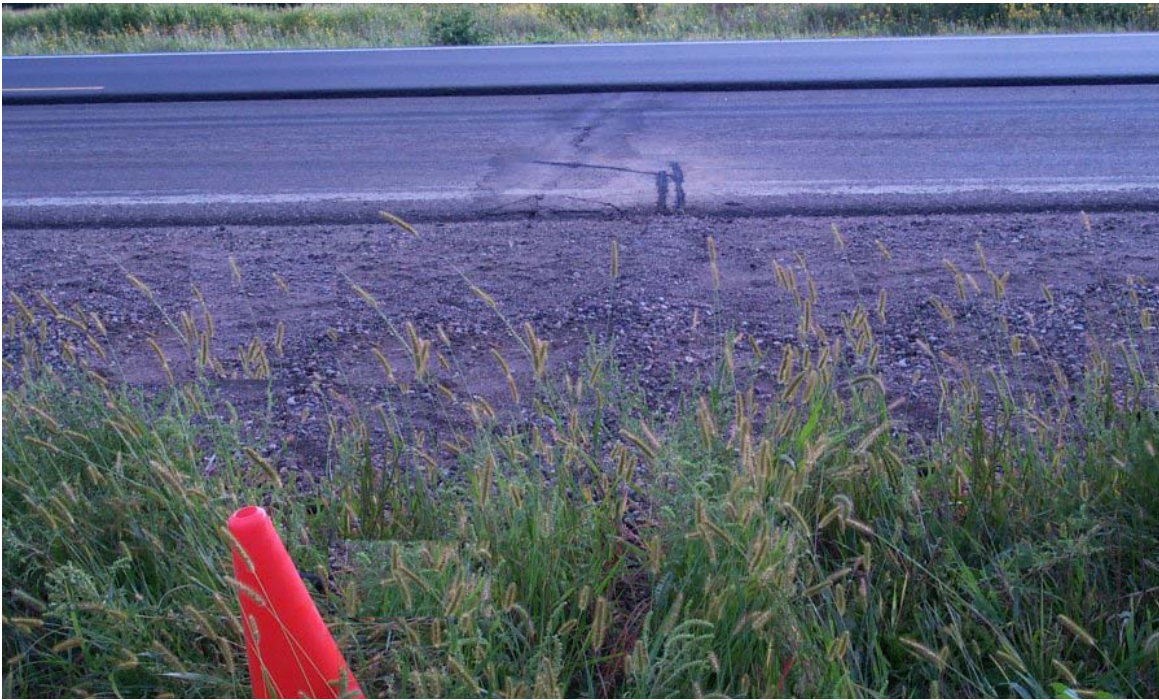
Figure 6.2. Instrumentation installation after placement of first lane.

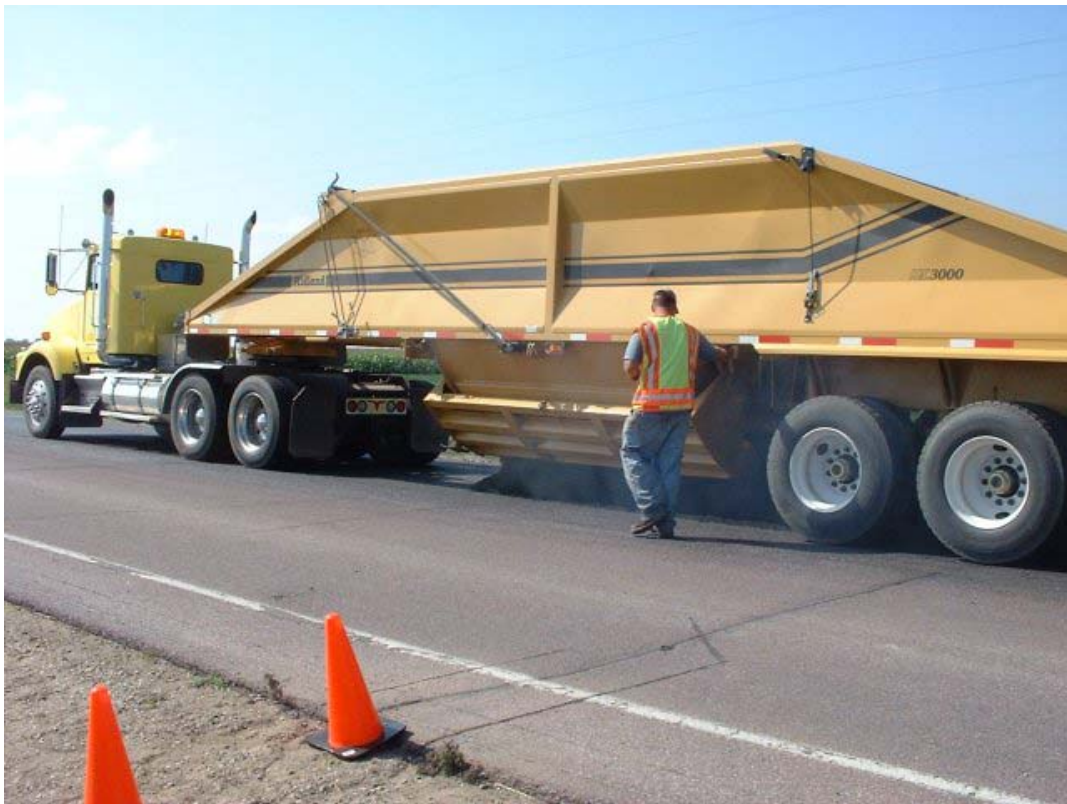
Figure 6.3. Impact of installation on construction activities.

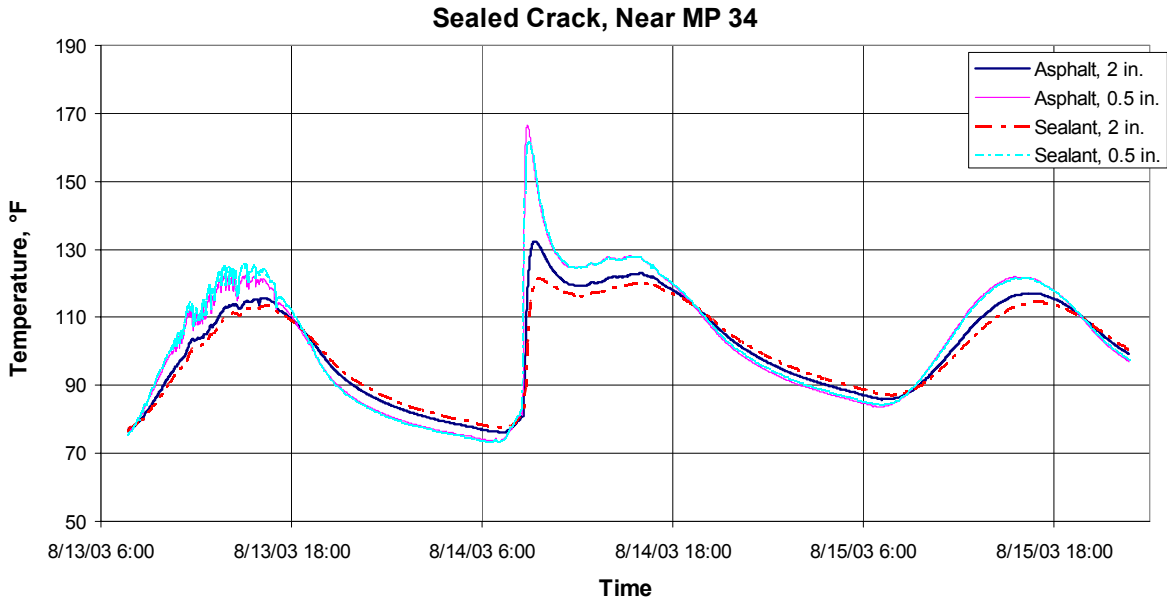
The graphs in Figures 6.4 and 6.5 show the temperature variation at different depths both in the crack and in the asphalt for the sites at MP 34 and 19, respectively.

Figure 6.4. Temperature variations near milepost 34 on TH 22, Mn/DOT District 7.

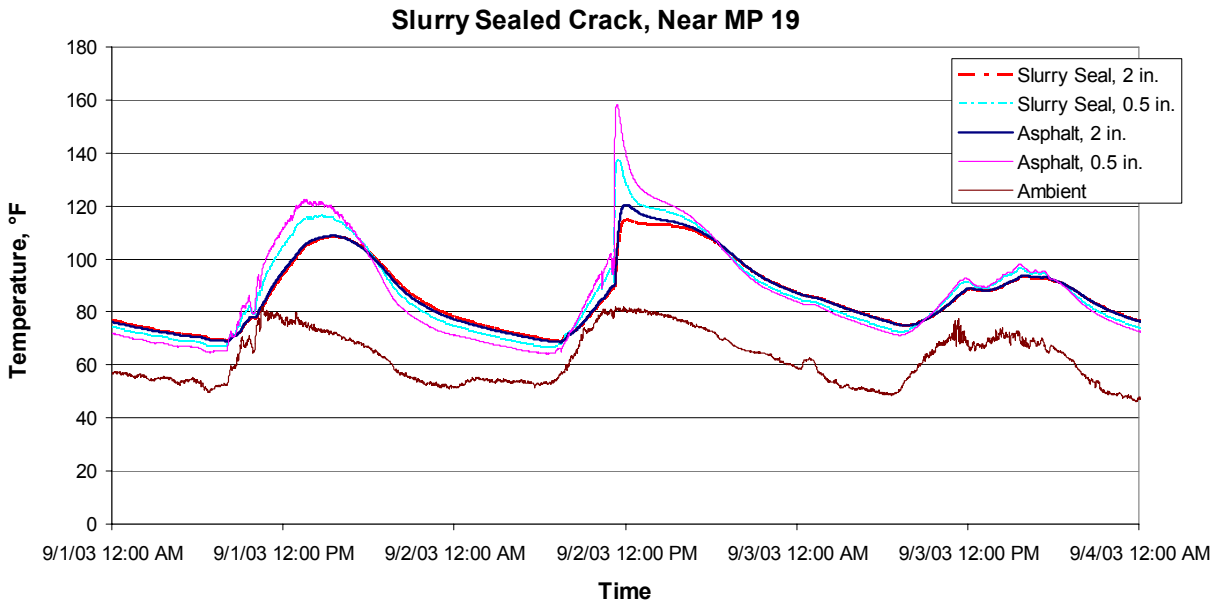
Figure 6.5. Temperature variations near milepost 19 on TH 22, Mn/DOT District 7.

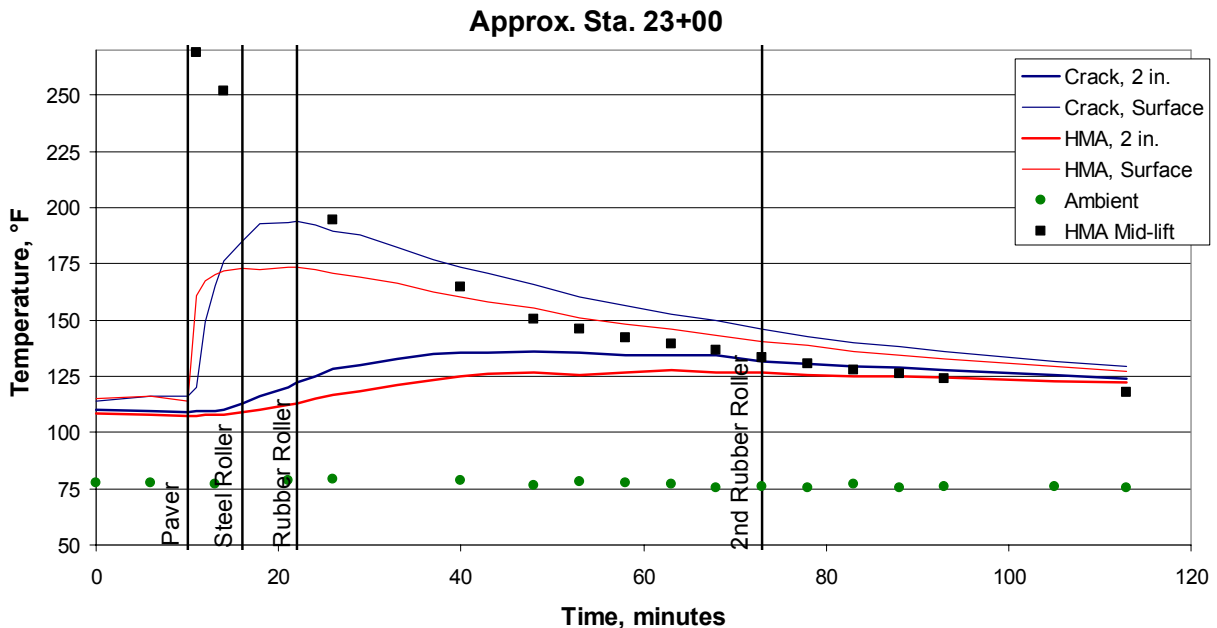
The graph in Figure 6.9 shows the temperature variations in the hot-mix asphalt, the ambient temperature, and at two locations (at the surface or the original pavement and two inches below) both in the crack and nearby in the asphalt.

Figure 6.9. Temperature variations, CSAH 9, Lyon County.

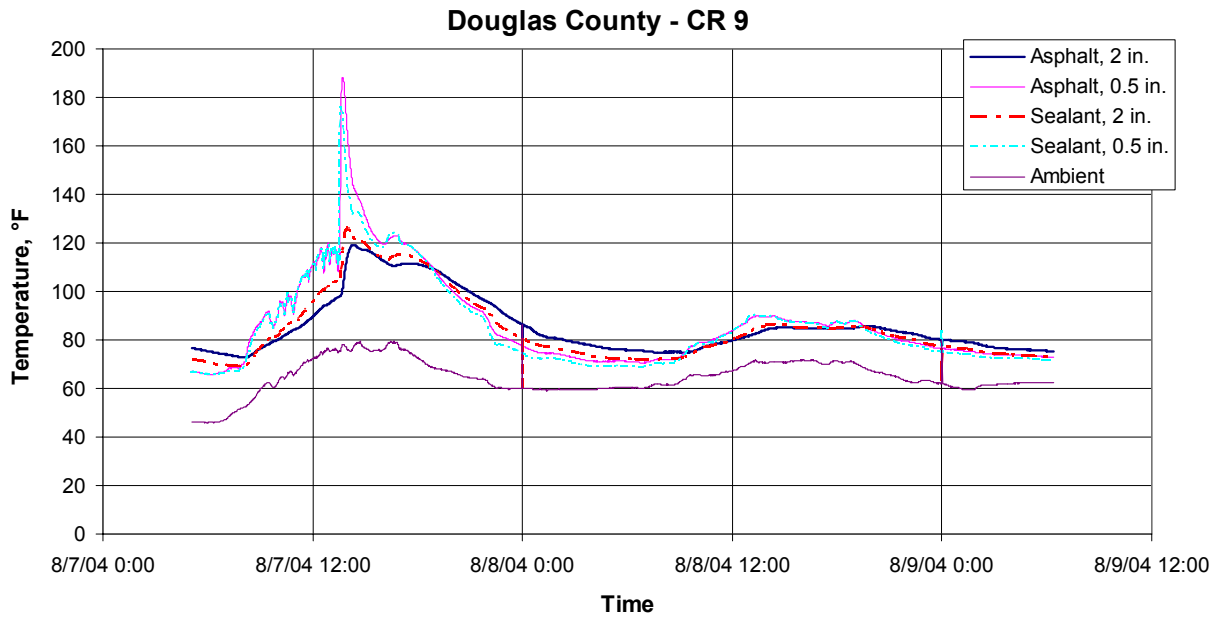
Figure 6.16. Temperature data from tight-blade leveling operation on County Road 9, Douglas County.

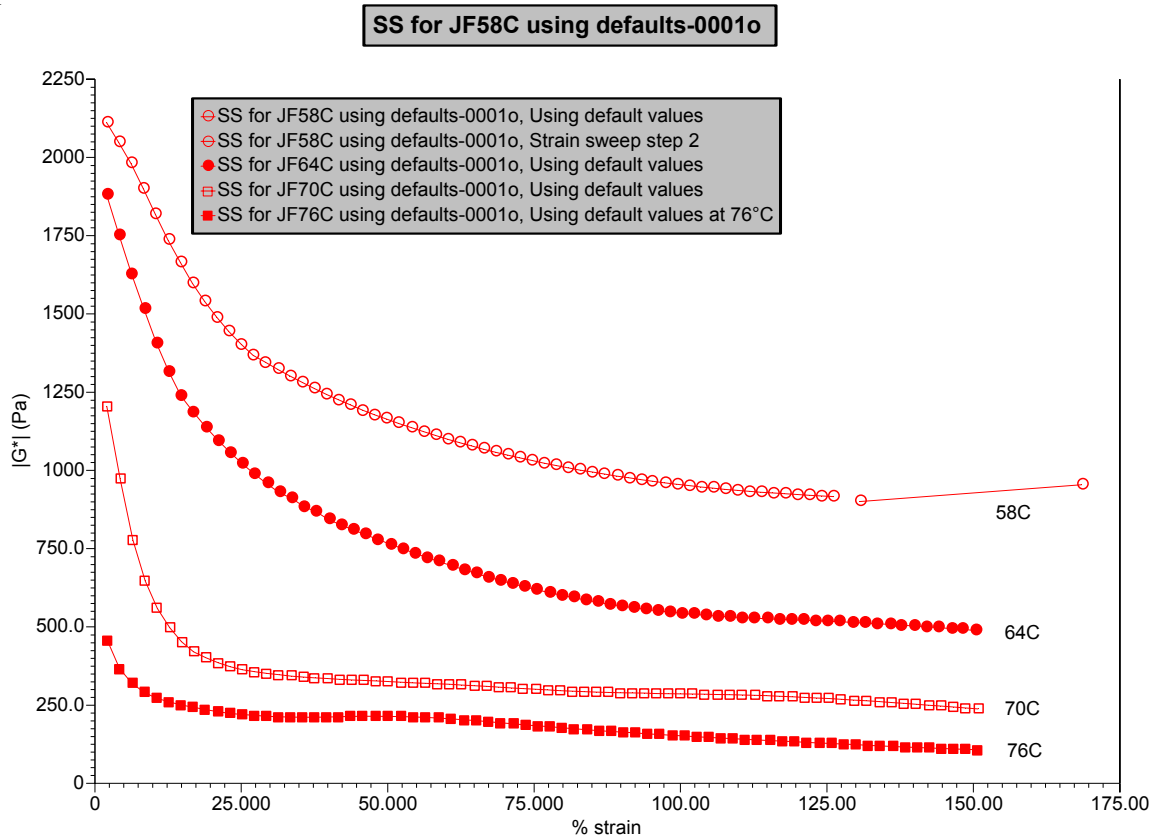
fundamental material properties. Figure 7.1 shows the strain sweep results for a sample material. The decrease in complex shear modulus can be seen at both higher strains and at higher temperatures.

Figure 7.1. Strain sweep results.

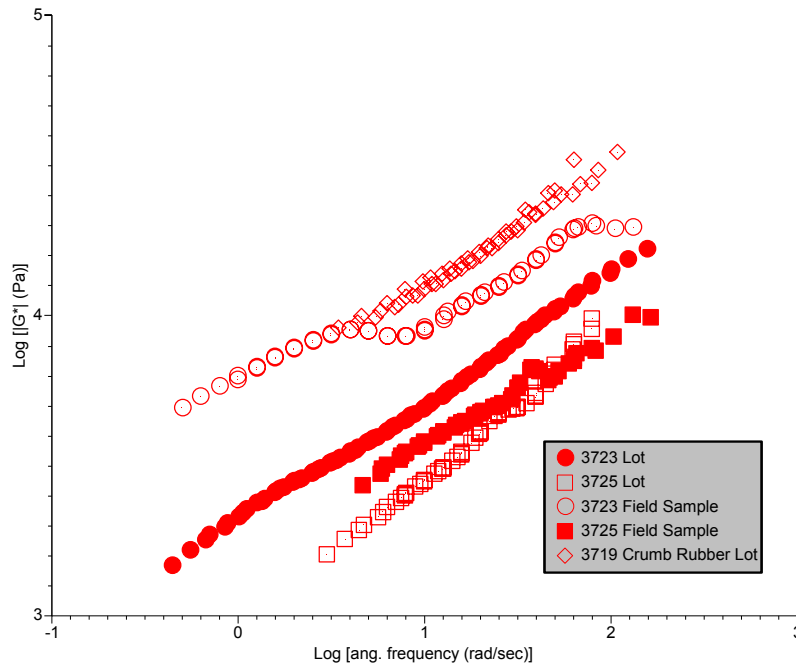
- Stiffening of the sealant is observed in the field samples taken from existing pavement.
- At high temperatures, the complex shear modulus of the 3723 and 3719 materials are relatively the same but the 3723 is softer than 3719 materials at lower temperatures.
- At higher or intermediate temperatures, the stiffness of the 3725 field and new samples are different but at lower temperature they compare more closely.

Figure 7.2. Sealant master curves.

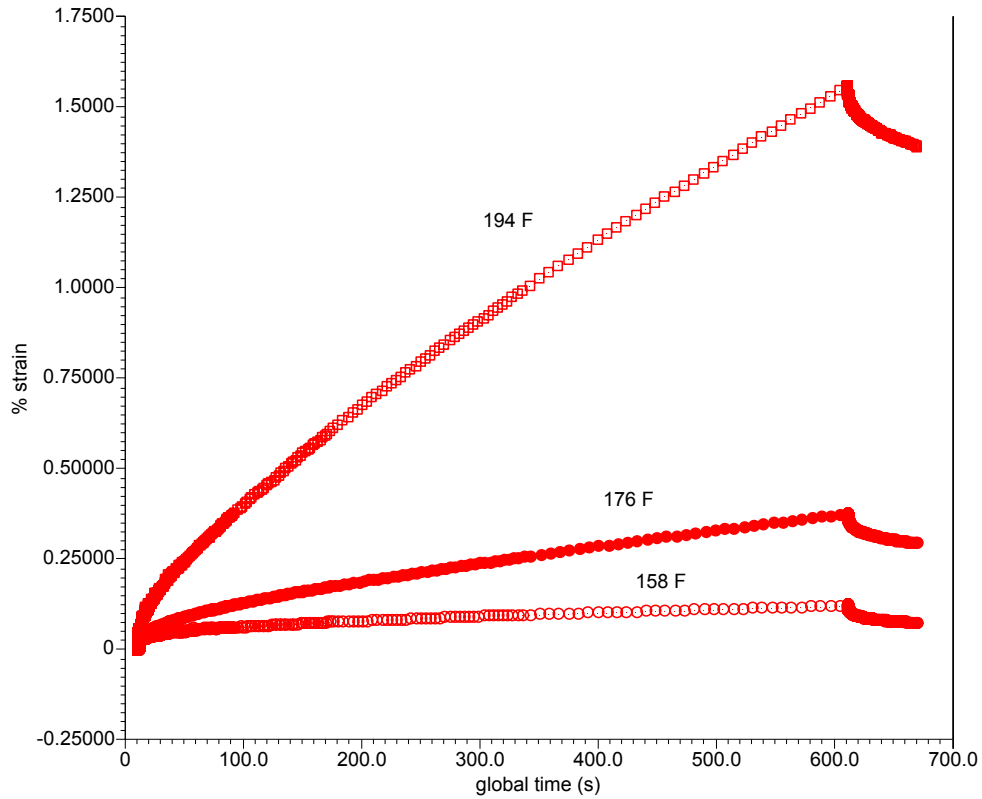
The creep and recovery test is conducted by placing a load (stress) on the sample for 10 minutes, then relaxing the load and measuring the recovery. Figure 7.3 shows the creep and recovery results for a three-year old 3723 sealant sampled from the field (TH 101) at temperatures in the range seen from the thermal profile data. At 158° F and 176° F, the sealant shows low strain and large recovery rates. At these temperatures, the sealant would resist any deformation and the material is mostly elastic in nature. At 194° F, the strain upon loading is higher as would be expected as the 205° F softening point is approached. This may support the theory that the sealant would become viscous at higher temperatures and be pushed forward under the rollers and as the pavement cools the sealant again regains its elasticity causing the material to cause bumps.

Figure 7.3. Field sample creep results of 3723 material.

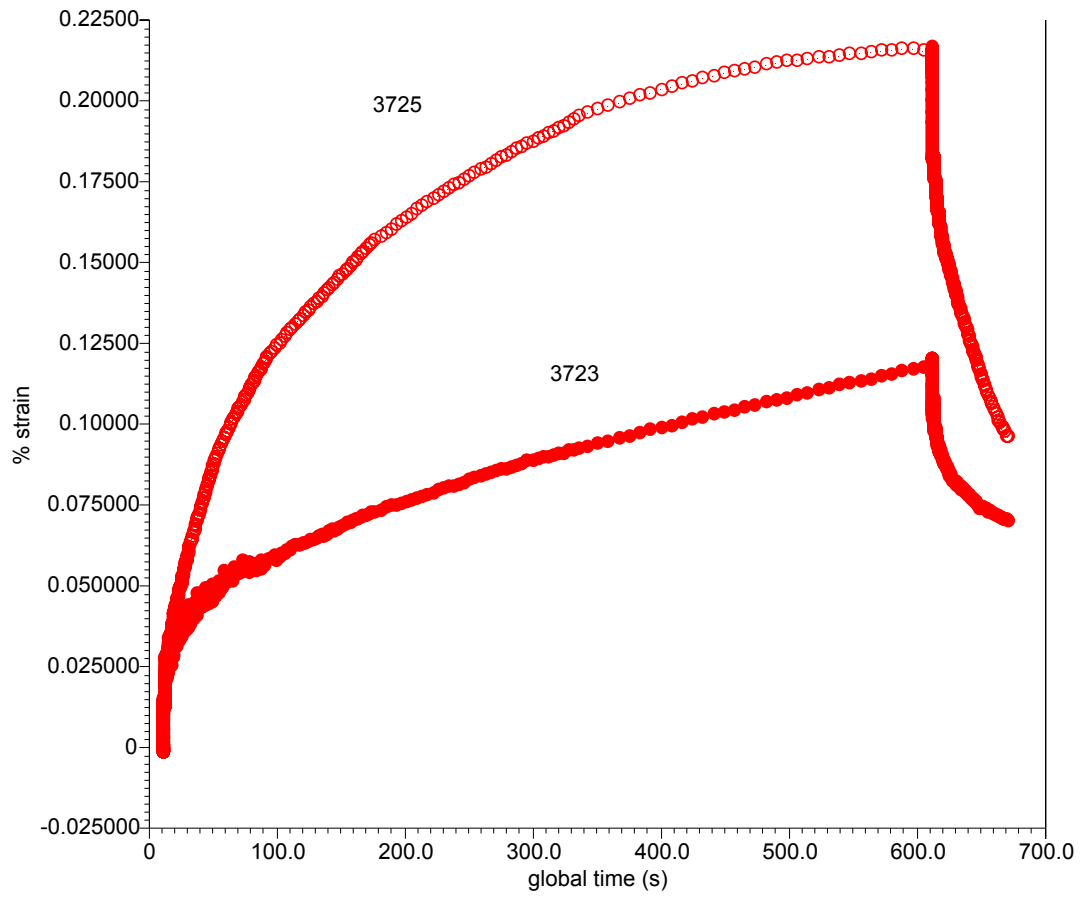
Figure 7.4 shows a comparison of the creep and recovery results of 3725 and 3723 sealants. The softer 3725 sealant deforms more under loads but recovers more due to the increased polymer content and soft asphalt in the 3725 formulation. These results would indicate that 3725 might give more problems with creating bumps in an HMA overlay situation, but more field research needs to be done to confirm this.

Figure 7.4. Creep comparison of 3723 and 3725 field samples.
